Investigation Report

Published: June 2024

U.S. Chemical Safety and Hazard Investigation Board

The September 20, 2022, naphtha release and fire at the BP-Husky Toledo Refinery fatally injured two employees, who were brothers:

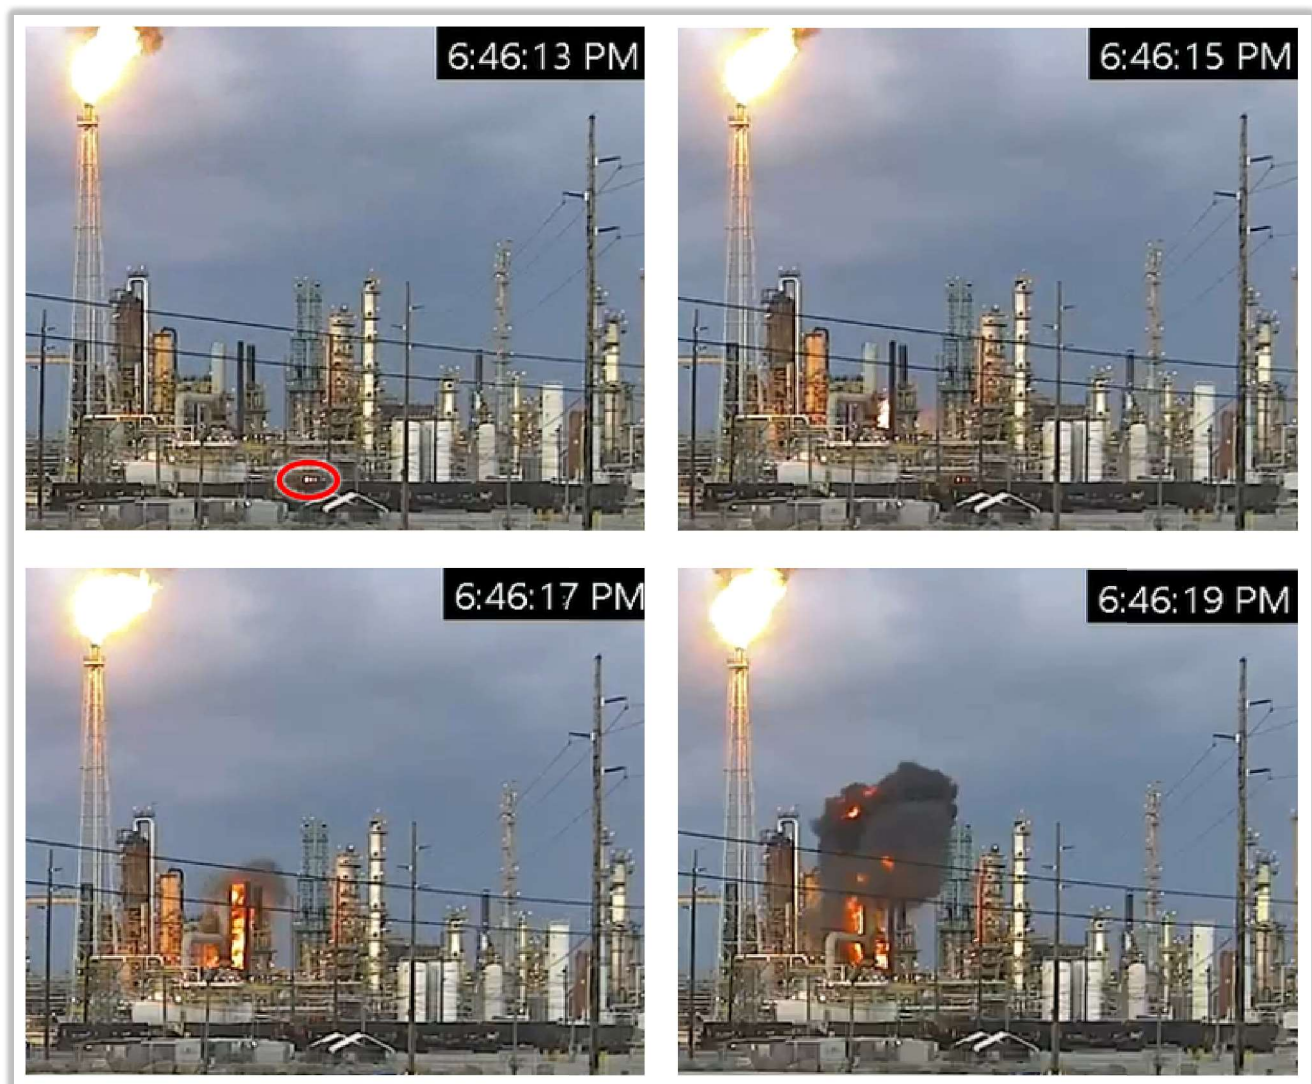
An approaching rainstorm shifted the wind, which likely directed the vapor cloud toward the nearby Crude 1 Furnace, the likely ignition source. The vapor cloud ignited at 6:46 p.m., as shown in **Figure 11**. **Figure 12** shows the Crude 1 Furnace's proximity to the Fuel Gas Mix Drum, the area of the naphtha release, and the eyewitness's location.

Figure 11: Vapor cloud ignition and the ensuing six seconds. Ignition at Crude Furnace (circled in red, upper left photo). (Credit: BP with annotations by CSB)

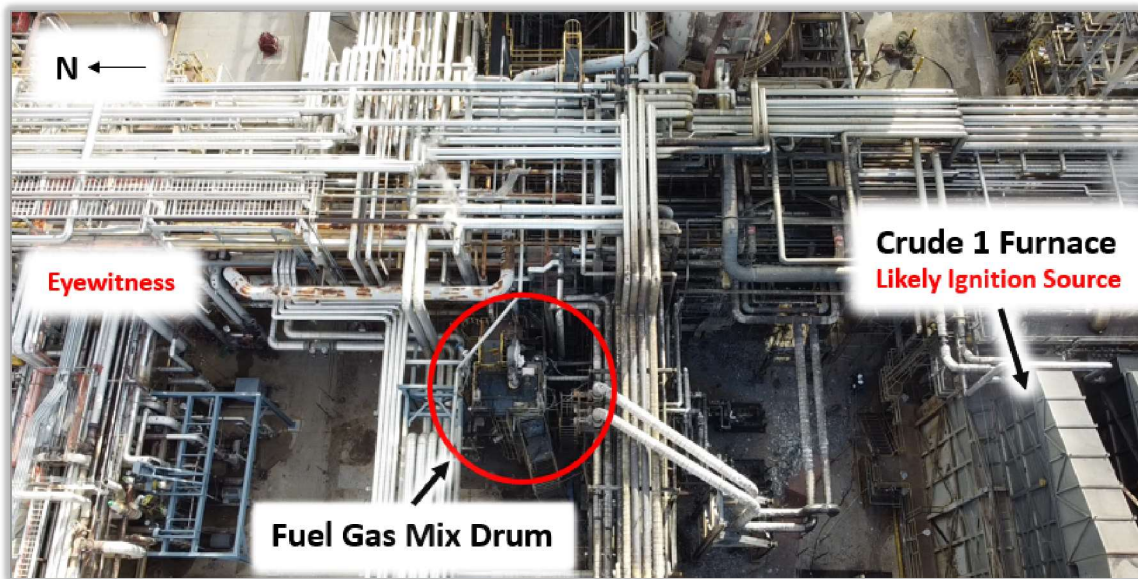
Figure 12: Overhead view of naphtha release, likely ignition source, and eyewitness location. (Credit: BP with annotations by CSB)

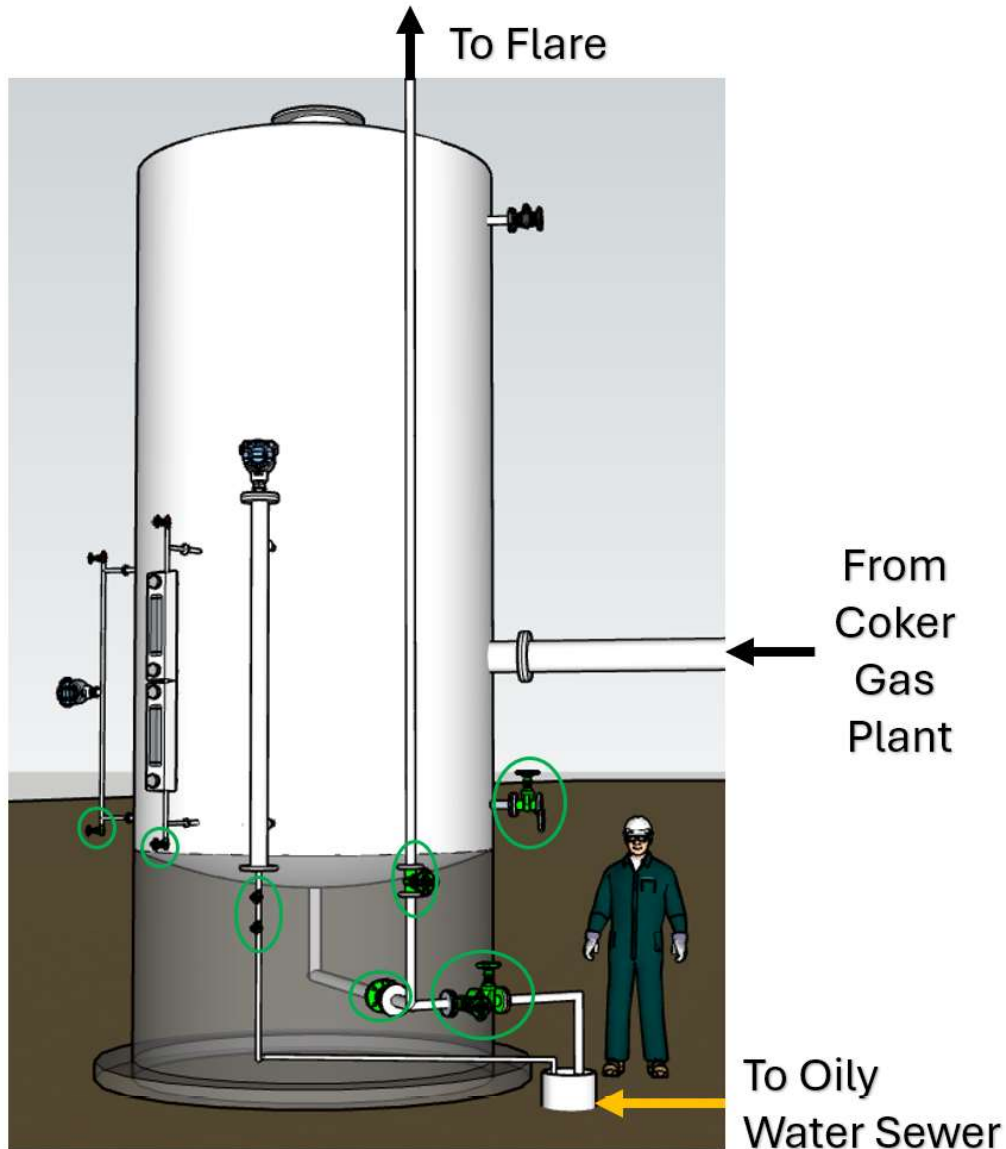
Figure 28. BP Toledo Refinery Fuel Gas Mix Drum. Valves circled in green were opened to drain and release naphtha. (Credit: CSB)

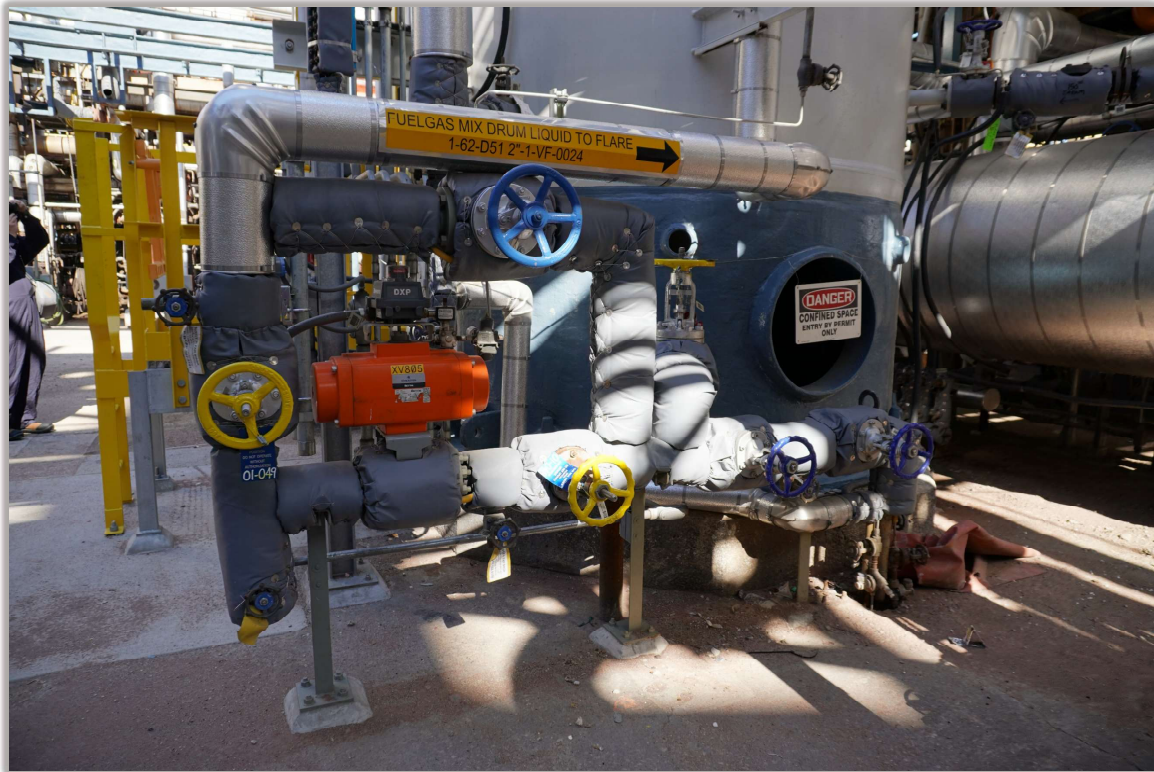
Figure 32. Toledo Refinery Fuel Gas Mix Drum with modifications made after the September 20, 2022, incident. (Credit: CSB)

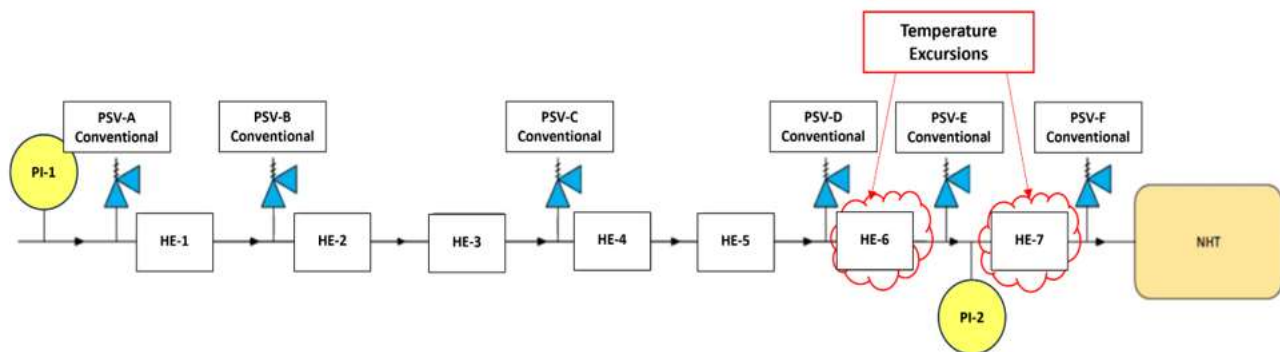
Figure A1-2. Heat exchangers that experienced temperature excursions. (Credit: BP with annotations by CSB)^d

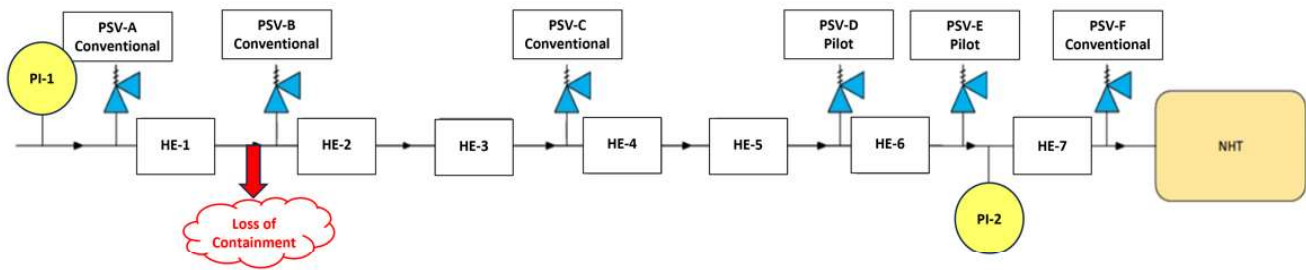
Figure A1-4. Location of loss of containment. (Credit: BP with annotations by CSB)
