VOLUME: 2

DATE: MARCH 12, 2025

INCIDENT REPORTS

EVENTS REPORTED TO THE CSB UNDER THE ACCIDENTAL RELEASE REPORTING RULE

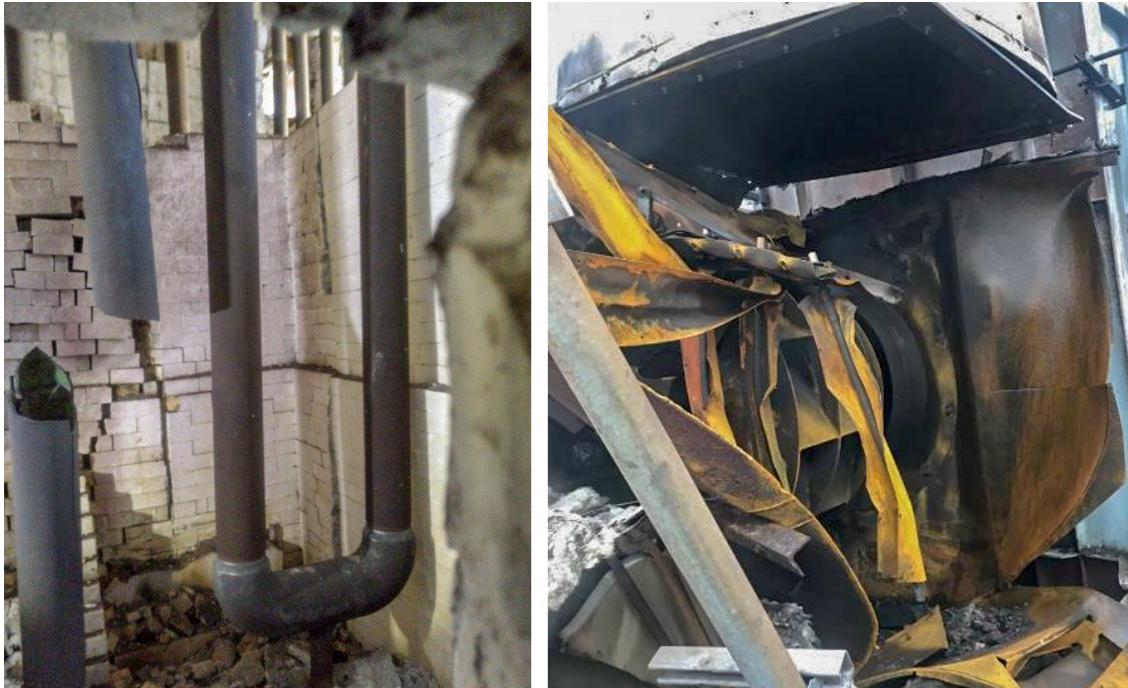
Figure 5. Fired heater explosion damage. The left image shows the broken tube and walls, and the right image shows a fan. (Credit: Chevron Phillips)

Chevron Phillips' investigation determined that the tube failure likely occurred because the fired heater tubes were shut down without decoking. Coke fouling can insulate the tube surface, resulting in local hotspots and increasing the risk of thermal shock and tube failure in fired heaters. These conditions stressed the tube's walls when the metal cooled faster than the internal coke, breaking the tube. Chevron Phillips' investigation concluded that hot insulation inside the firebox likely ignited the gas (autoignition).

Based on Chevron Phillips's investigation, the CSB determined that the probable cause of the incident was a fired heater tube failure from thermal stress due to the rapid shutdown. When the tube broke, a hydrogen and hydrocarbon gas mixture from downstream equipment flowed into the firebox. Hot insulation within the firebox likely ignited the flammable gas, resulting in an explosion. Inadequate winterization of multiple valves, instruments, and control systems contributed to the incident.

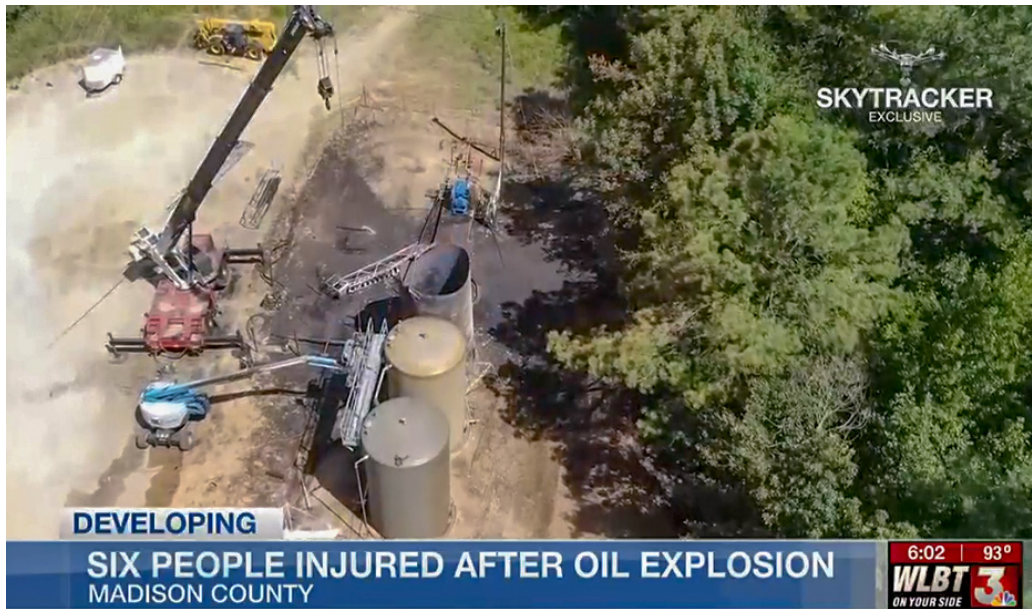
Figure 1. News report image after the explosion at Red Hancock. (Credit: WLBT News)

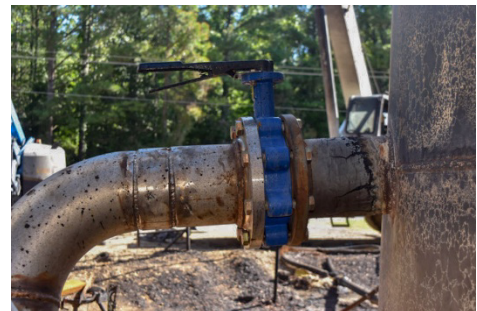
Red Hancock’s investigation found that although most of the liquid was removed from the two tanks that were not replaced, some salt water, residual hydrocarbon material, and air remained inside these tanks. At the time of the incident, seven Red Hancock employees were completing the tank replacement work, which included installing an elevated walkway between the tanks and finishing piping and structural connections. While welding piping between the two middle tanks, one of the employees opened a valve (**Figure 2**) to the older tank that contained residual crude condensate material, likely releasing some hydrocarbon vapors into the new piping being welded. The flammable vapor ignited, and flames traveled back into the

Figure 2. Open valve between new piping (left) and an old tank (right). (Credit: Red Hancock)

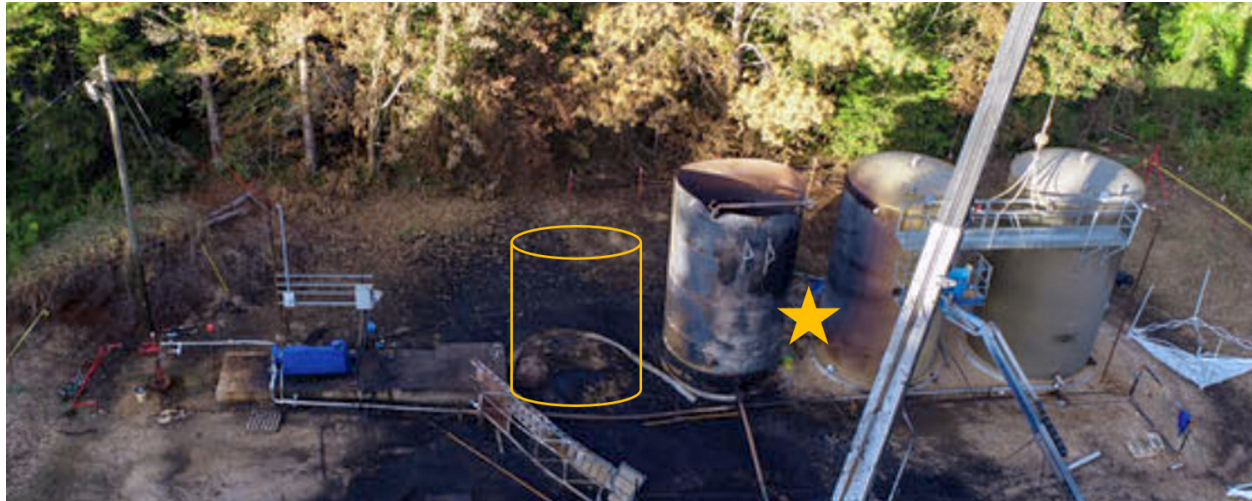
tank, resulting in an explosion and fire that ejected the top of the tank. In addition, the blast launched and forcefully propelled an adjacent tank approximately 80 feet into the woods (Figure 3).

Figure 3. This post-incident photo shows the location of the welding activity that triggered the explosion (gold star) and the pre-incident location of the fourth tank, which was launched by the blast and propelled into the woods shown in the background. (Credit: Red Hancock with annotations by CSB)

Based on Red Hancock’s and OSHA’s investigations, the CSB determined that the probable cause of the incident was the presence of flammable vapors near a welding activity being performed. Not thoroughly draining, cleaning, and purging the tanks to remove the flammable material before starting construction contributed to the incident. Had the tanks been thoroughly drained, cleaned, and purged prior to the commencement of construction, this incident likely could have been prevented.

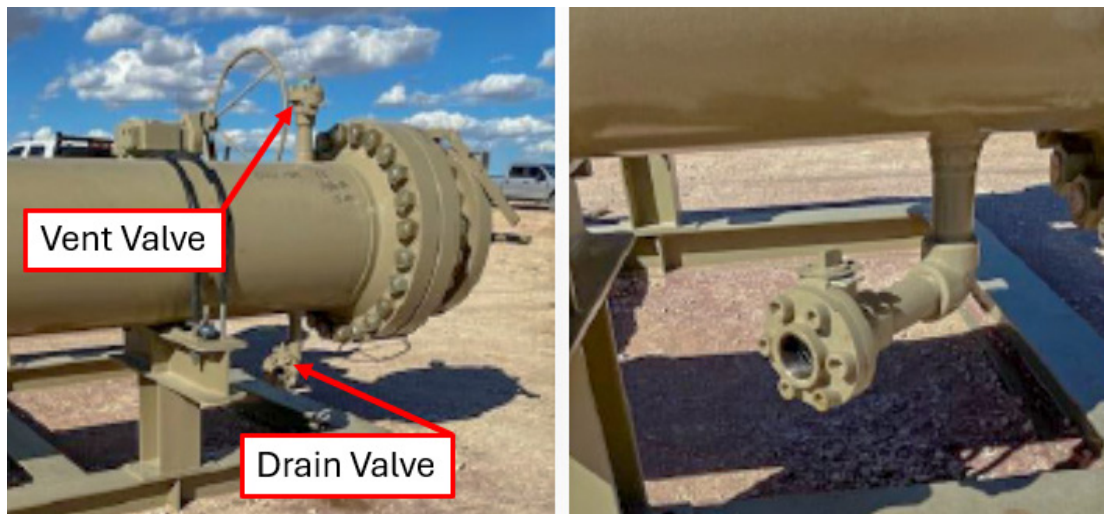
When the two workers went to remove the pig from the receiver, the pressure in the receiver was above 1,150 pounds per square inch (“psi”). To safely remove the pig, the pressure needed to be reduced by relieving it through a vent valve located at the top of the receiver. The contractor initially tried to remove the plug from the vent valve to relieve the pressure but found that the plug could not be removed with hand tools. This indicated that there could be pressure between the valve and the plug, forcing the threads tightly against each other. The contractor concluded that the vent valve might be leaking and decided to relieve the pressure inside the receiver using the drain valve instead, which was located at the bottom of the receiver (**Figure 1**).

Figure 1. Orientation of the vent valve and drain valve (left) and post-incident position of the drain piping after opening the valve (right). (Credit: XTO, edited by the CSB)

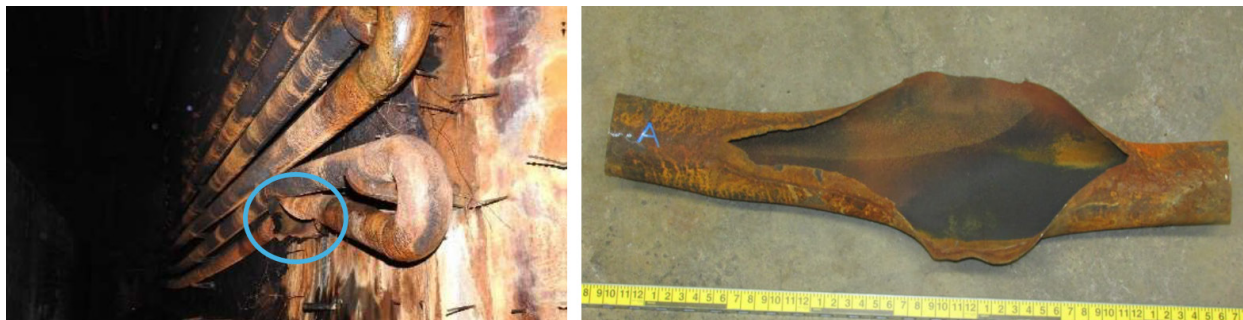
Delek's investigation identified that ambient temperatures at the facility dropped to 12 degrees Fahrenheit by 11:00 p.m. on the night of the incident. This cold weather caused operational issues with some instruments and controls, leading to low hydrocarbon flow through the tubes of a fired heater. The decreased flow resulted in reduced heat transfer, which likely caused the metal temperatures in the tubes to rise significantly. This high-temperature condition ultimately caused a tube to rupture (**Figure 2**), releasing flammable hydrocarbons into the firebox, where the existing burner flame ignited them. Delek commissioned a metallurgical examination and found that the tube ruptured due to creep damage (which results from prolonged exposure to stress at elevated temperatures) and short-term overheating.

Figure 9. The ruptured tube within the fired heater (left) and after removal (right). (Credit: Delek)

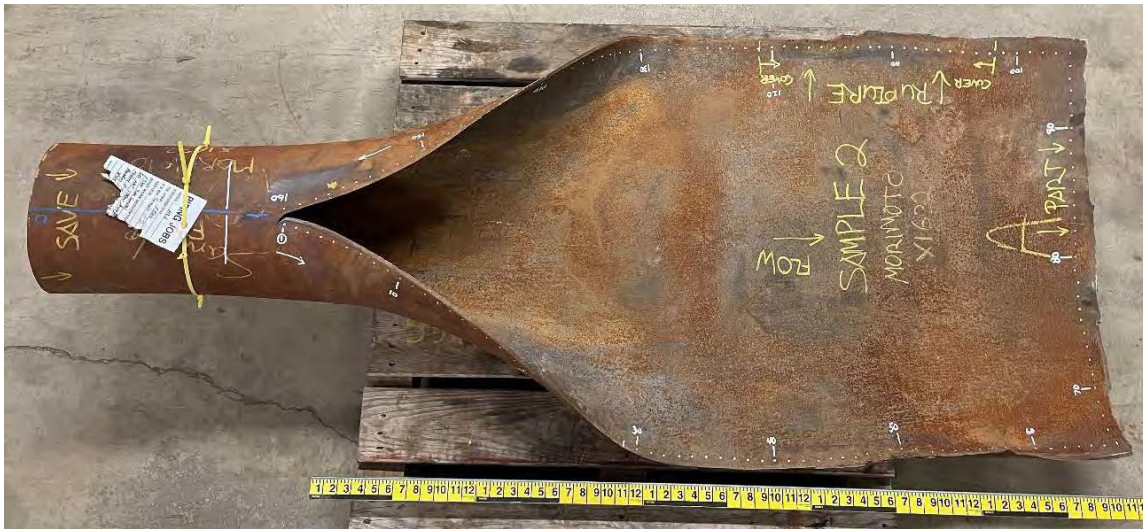
the tube failure was likely the result of a combination of localized creep damage (which results from prolonged exposure to stress at elevated temperatures) and short-term overheating.

Figure 11. Ruptured tube. (Credit: PBF Energy)

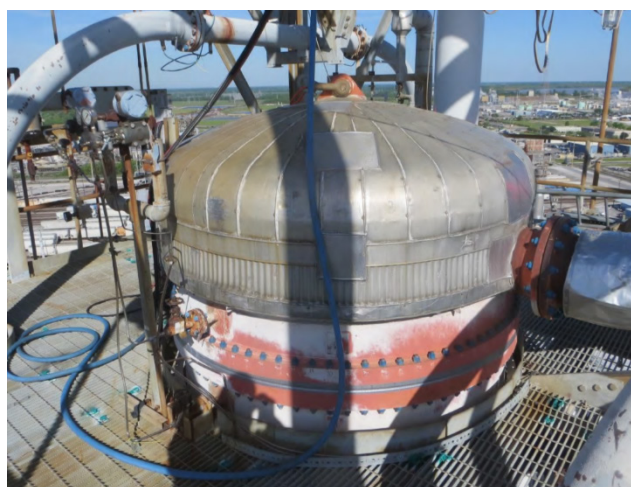
The vessel is connected to a flare system to vent unreacted gases. At the time of the incident, a series of valves were available to isolate the vessel from the flare system, but only one valve

Figure 2. Top head of incident vessel. (Credit: Dow)

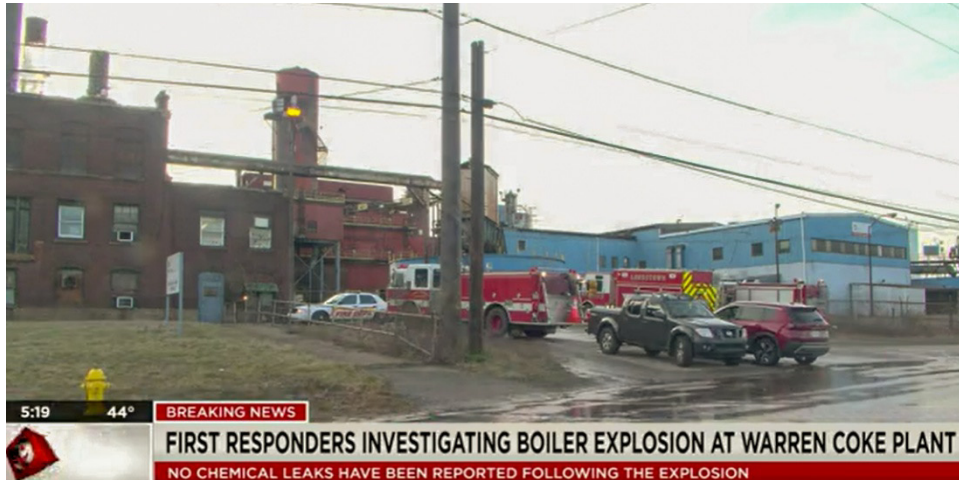
Figure 1. Emergency response after the explosion. (Credit: Cleveland 19 News)

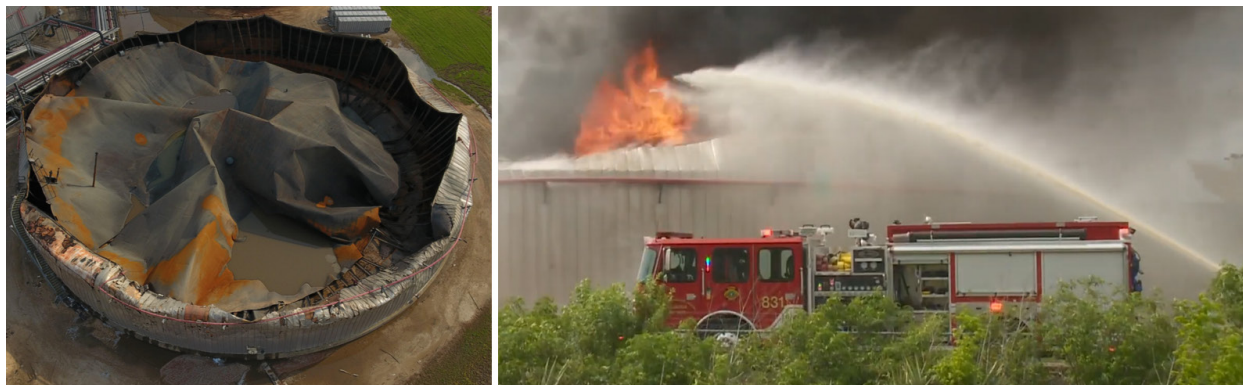
(Figure 2). Flammable hydrocarbon liquid burned in the tank for about nine hours before emergency responders extinguished the fire.

Figure 13. Post-incident photo of the damaged tank (left, Credit: IMTT) and the emergency response to the tank fire (right, Credit: WWL-TV).

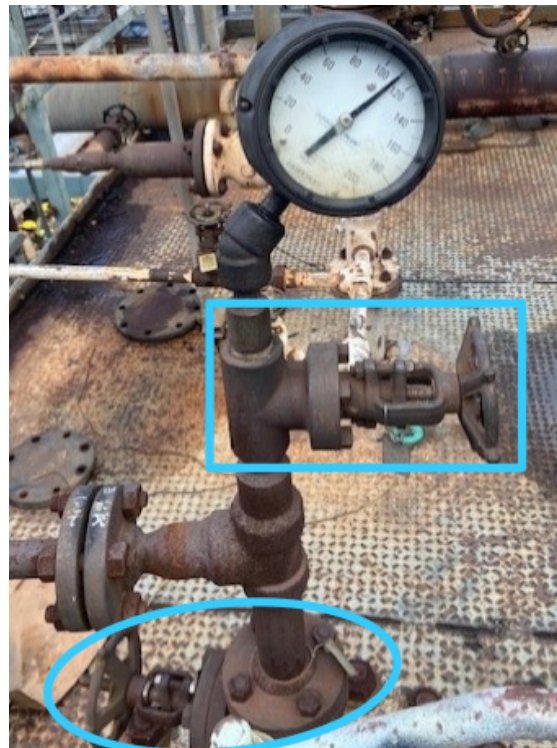
Figure 1. Photo of the pressure gauge and valves involved in the incident. (Credit: Marathon, annotations by CSB)

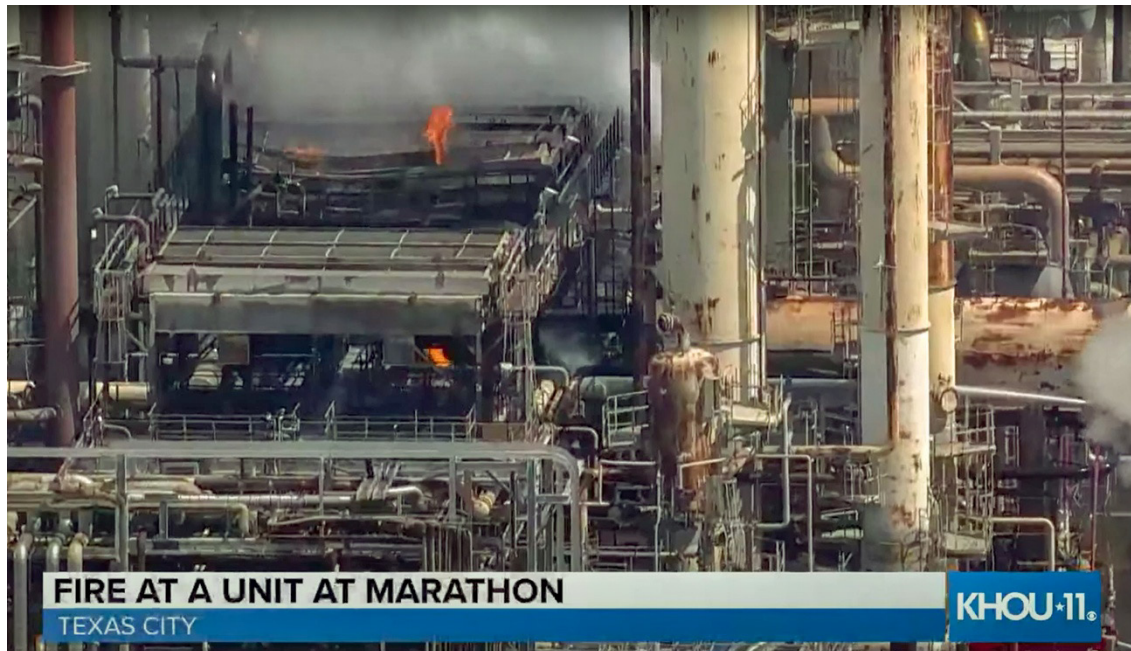
The heat from the fire ruptured piping and damaged other equipment (**Figure 2**). Employee 2 was able to exit the unit before the flammable naphtha ignited. Employee 1 did not escape from the elevated platform and was fatally injured by the fire.

Figure 15. Fire impacting elevated platforms. (Credit: KHOU 11 News)

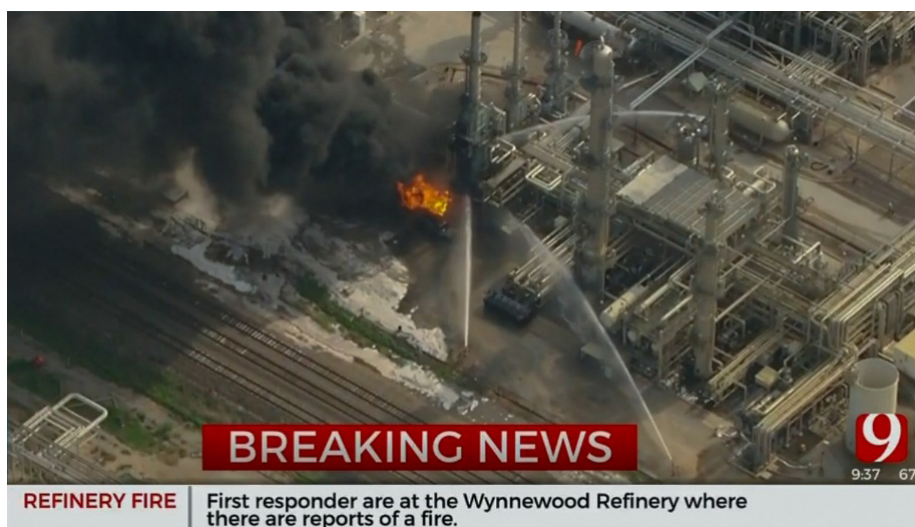
Figure 1. Emergency response to the fatal fire. (Credit: News 9)

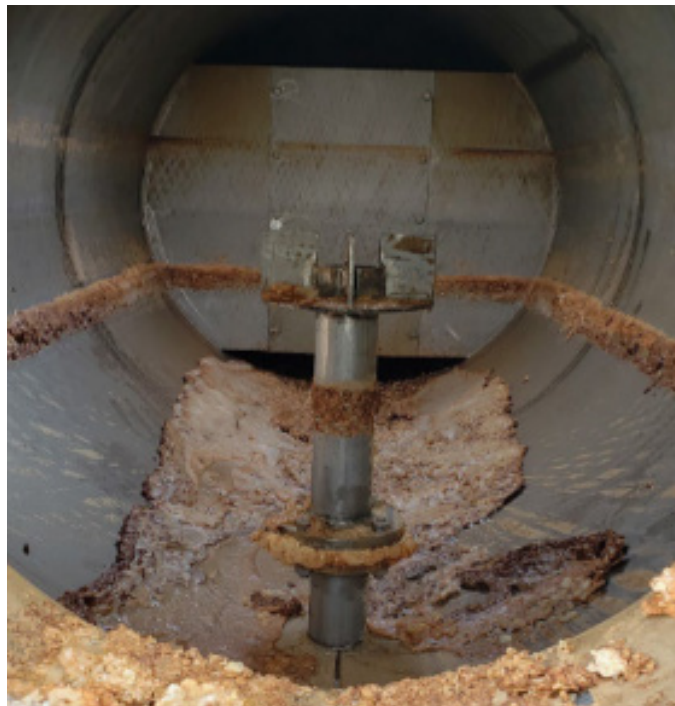
The incident occurred in SABIC’s latex production area during a maintenance shutdown. Employees were tasked with removing an internal part (a “baffle”) at the back of the horizontal tank (which was approximately five feet in diameter and nine feet in length). SABIC’s procedure stated that the tank should be cleaned using high-pressure water to remove any accumulated solids before entry. However, this procedure was not followed, and residual solids remained in the tank and potentially contained some butadiene (**Figure 1**). The work inside the tank disturbed these solids, which likely released about two pounds of butadiene vapor, creating a flammable atmosphere within a portion of the tank. In addition, while continual monitoring of the confined space was taking place during the entry, the end of the air monitor hose was not near the bottom of the tank where the solids were located, and this likely prevented the 5-gas detector from identifying the presence of flammable butadiene vapor.

Figure 1. Tank Containing Solids at SABIC. (Credit: SABIC)

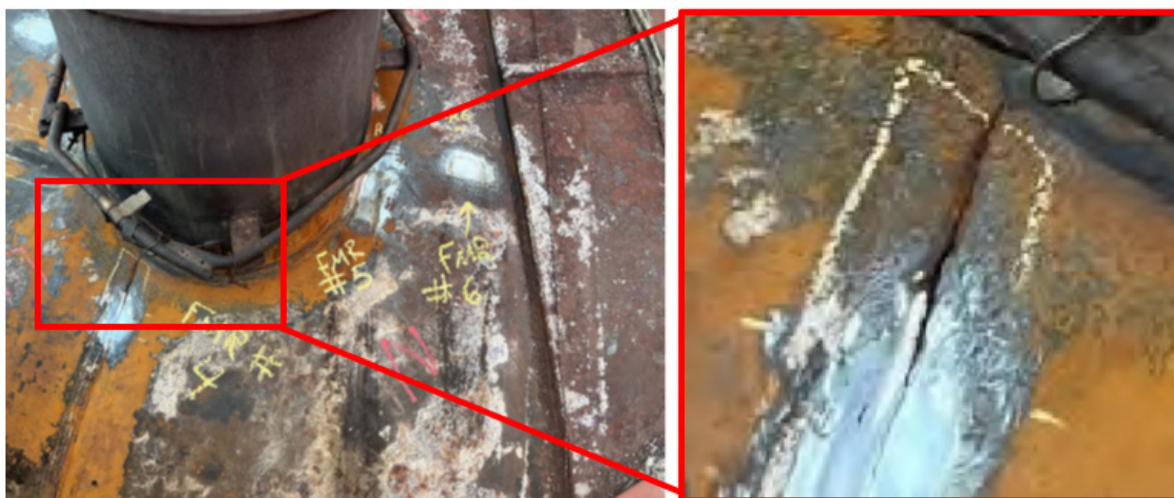
Figure 2. One of the cracks in the reactor’s head. (Credit: LyondellBasell, edited by the CSB)
