Investigation Report

Published: June 2024

U.S. Chemical Safety and Hazard Investigation Board

The September 20, 2022, naphtha release and fire at the BP-Husky Toledo Refinery fatally injured two employees, who were brothers:

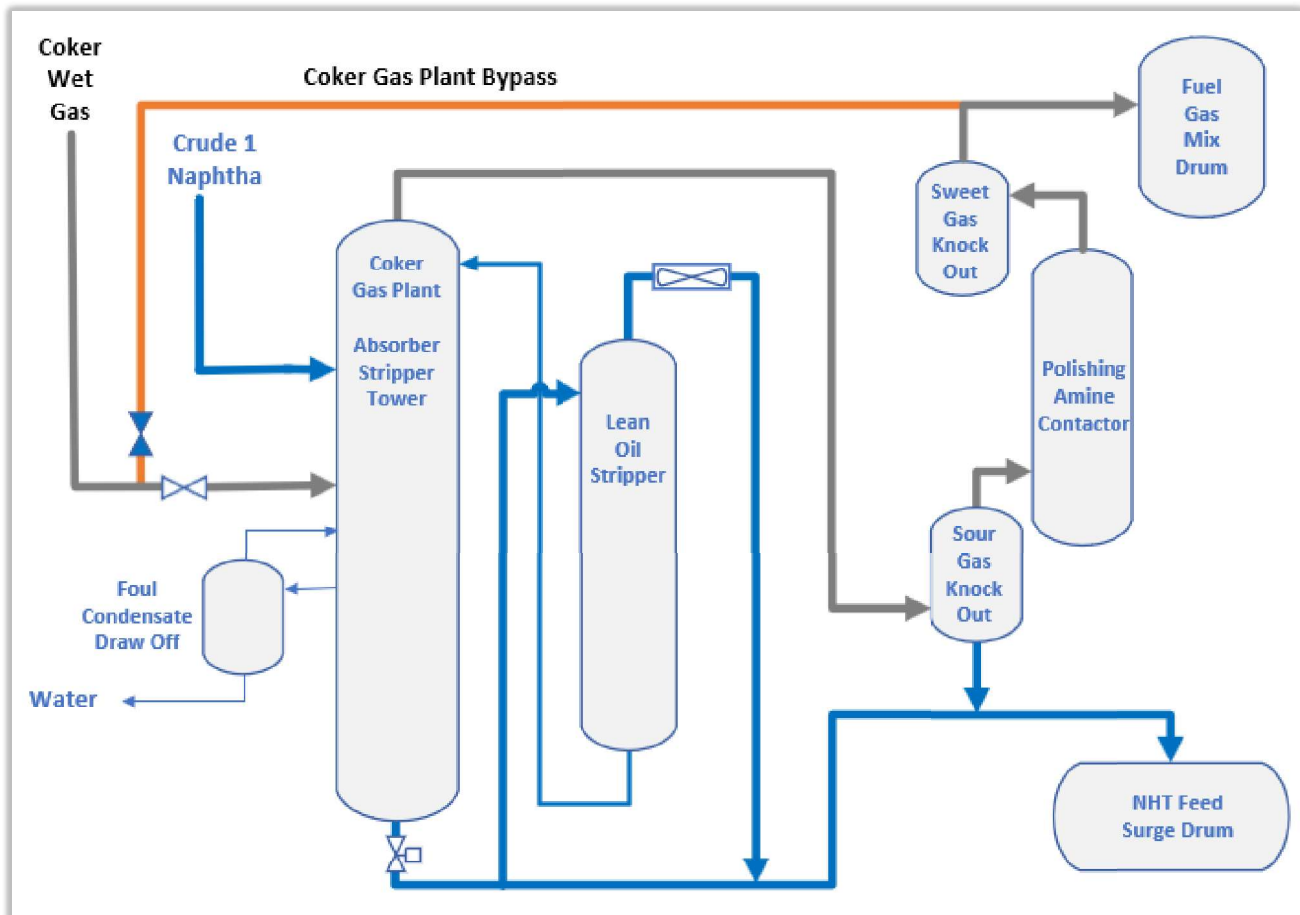
Figure 6. Coker Gas Plant. A simplified schematic of BP's process to remove sulfur from coker wet gas. (Credit: CSB)

The coker wet gas can also bypass the Coker Gas Plant and flow directly to the Fuel Gas Mix Drum as shown in **Figure 6** in orange. The bypass line allows untreated coker wet gas to be directly sent to the Fuel Gas Mix Drum when the refinery needs to perform maintenance on the Coker Gas Plant.^a

Naphtha and water from the Crude 1 Overhead Accumulator Drum flowed to the Coker Gas Plant Absorber Stripper Tower resulting in water collecting in the Coker Gas Plant Absorber Stripper Tower Foul Condensate Draw Off Drum (See **Figure 6**).^b Once full, the Foul Condensate Draw Off Drum began to backflow and returned water back to the Absorber Stripper Tower.

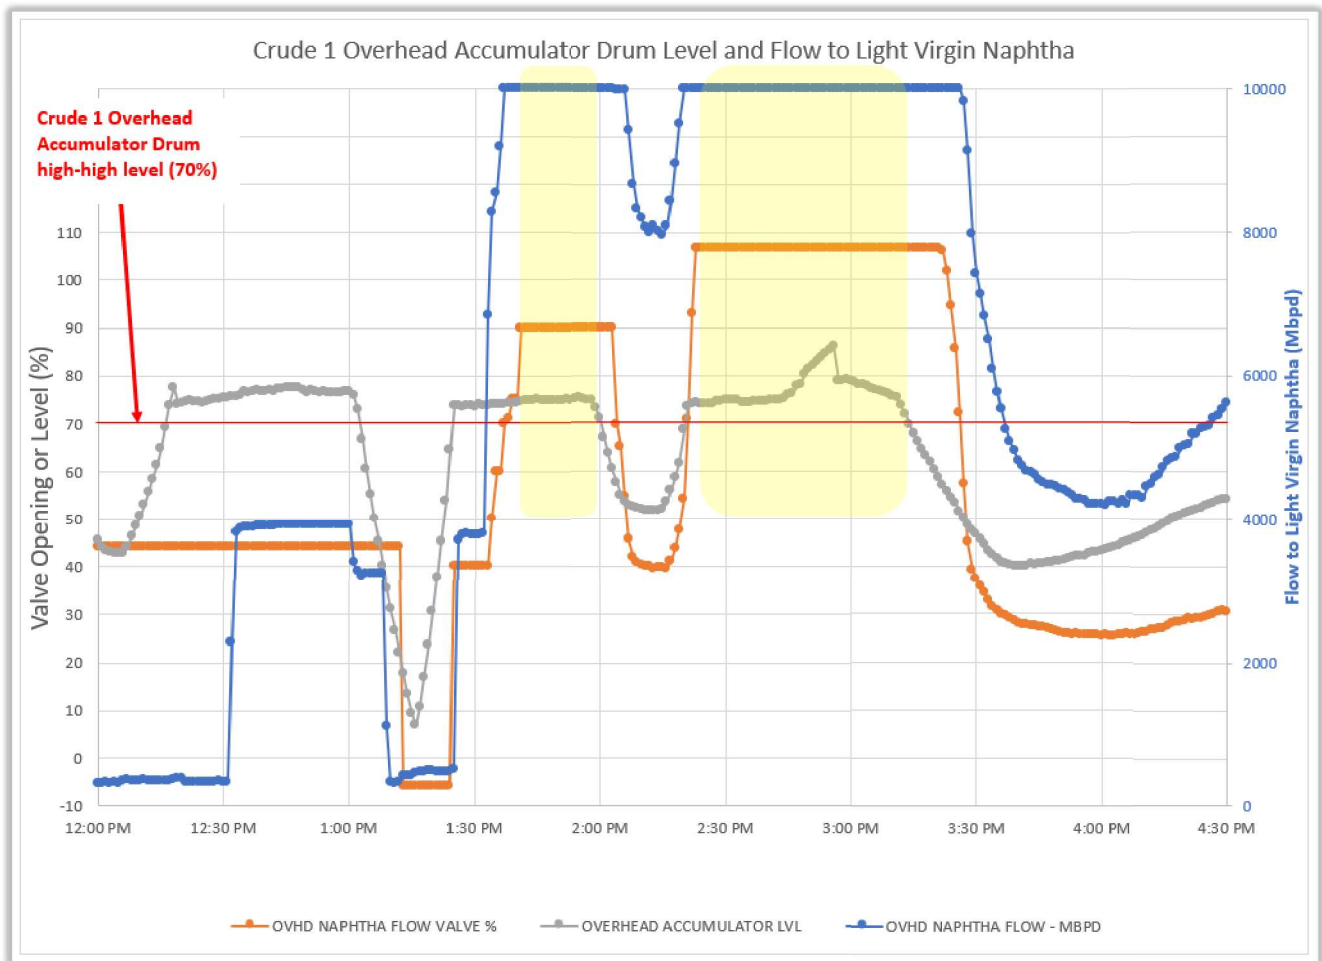
Figure 20: Crude 1 Overhead Accumulator Drum level control and flow to Light Virgin Naphtha. The yellow shaded areas indicate periods of accumulator level (gray) over the high-high alarm setpoint, while the flow meter to Light Virgin Naphtha (blue) was out of range and the flow control valve (orange) nearly or fully opened. (Credit: CSB)

unit shut down and the Coker Gas Plant bypassed. Ultimately, it was decided that neither shutdown nor circulation would be done at that time, which allowed the crude oil feed to Crude 1 to continue, even though the Crude 1 Tower had overpressured eight times (**Figure 21**), and the Crude 1 Overhead Accumulator Drum level had been above the high-high alarm point for approximately two hours (**Figure 20**), by 3:00 p.m.

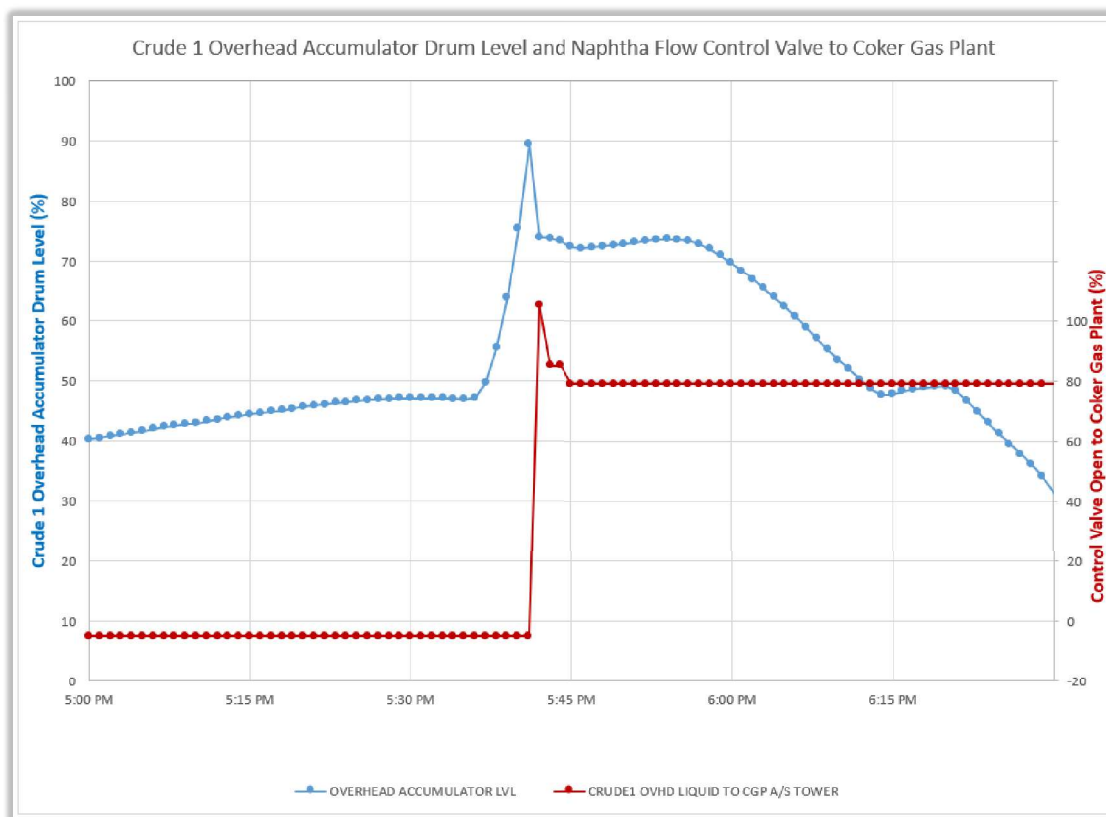
The Crude 1 Tower upset created a tower overhead flow surge a few minutes later, which in turn filled the Crude 1 Overhead Accumulator Drum. Within a five-minute period, the Crude 1 Overhead Accumulator Drum level rose from a steady state of 47 percent to 68 percent (the high level alarm), to 70 percent (the high-high level alarm), and finally to 89 percent level at 5:40 p.m. The Crude 1 Overhead Accumulator Drum level increased so rapidly that the level indication went from 65 percent to 89 percent in less than two minutes. In response to this rapid level increase, the board operators searched for ways to reduce level in the drum quickly. With other liquid naphtha flow paths out of the Crude 1 Overhead Accumulator Drum already either at full capacity or shut down,^a a board operator opened the naphtha flow control valve to the Coker Gas Plant in an effort to reduce the Crude 1 Overhead Accumulator Drum level even though the Coker Gas Plant was intended to be bypassed at the time. **Figure 24** below shows this valve opening (in red) and the Crude 1 Overhead Accumulator Drum's rapid level increase and resulting decrease (in blue) after the naphtha flow control valve to the Coker Gas Plant was opened.

Figure 24: Crude 1 Overhead Accumulator Drum level (blue) and naphtha flow control valve to the Coker Gas Plant opening (red) in response to the high level. (Credit: CSB)

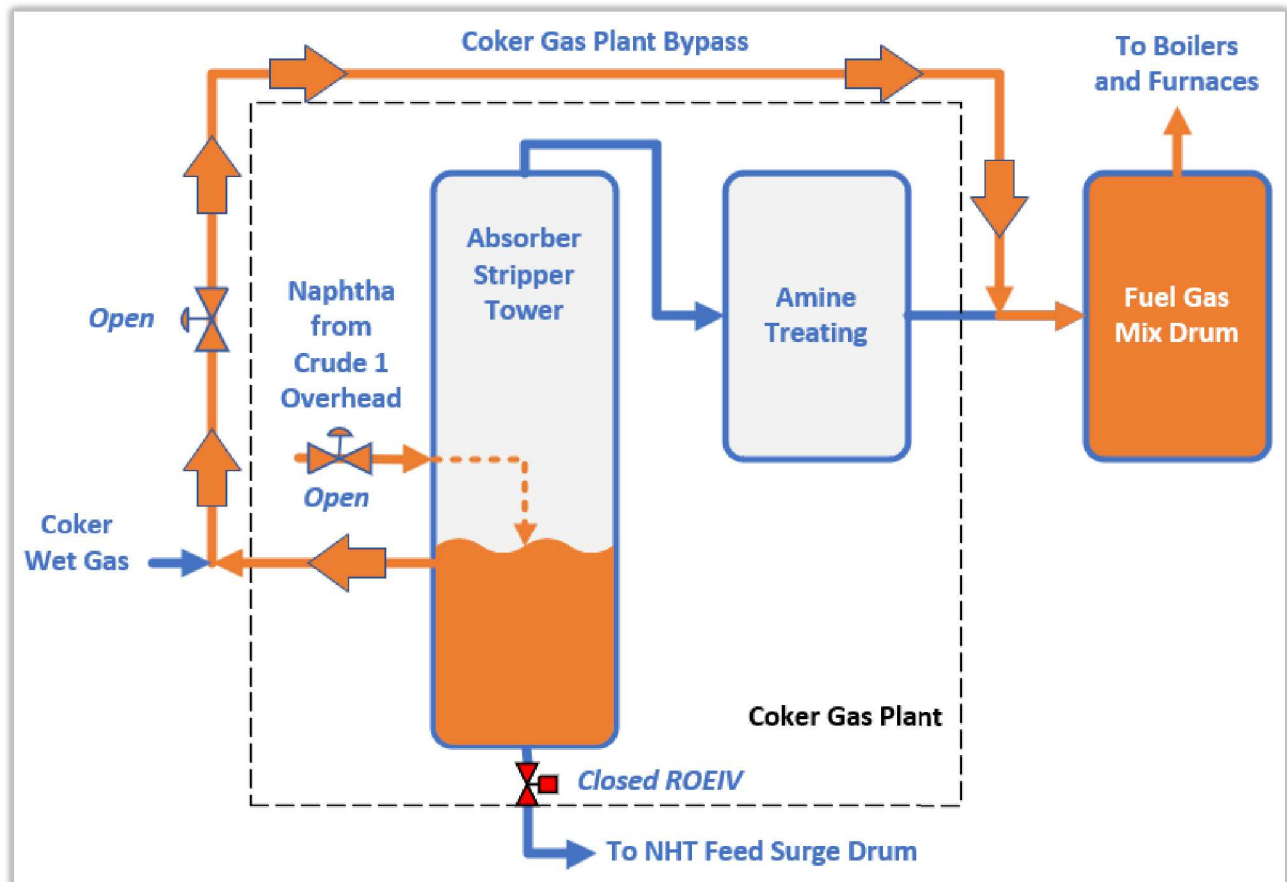
Once the Absorber Stripper Tower filled with liquid naphtha up to the elevation of the coker wet gas inlet piping, a line normally for gas flow only, the liquid naphtha overflowed into the Coker Gas Plant bypass piping and into the Fuel Gas Mix Drum. **Figure 26** below shows the overflow path from the Coker Gas Plant Absorber Stripper Tower to the Fuel Gas Mix Drum.

Figure 26: Overflow path from Coker Gas Plant to Fuel Gas Mix Drum (orange arrows).^a (Credit: CSB)

The closed ROEIV hastened the overflow into the Fuel Gas Mix Drum through the open bypass line, but the overflow likely would have occurred even if the ROEIV had been open. This was demonstrated in a 2019 near miss,^b similar to the September 20, 2022, incident, in which the ROEIV was open, but the overflow from the Absorber Stripper Tower, through the Coker Gas Plant bypass, to the Fuel Gas Mix Drum still occurred. This indicates that the inflow to the Absorber Stripper Tower was greater than the outflow from it even with the ROEIV open.

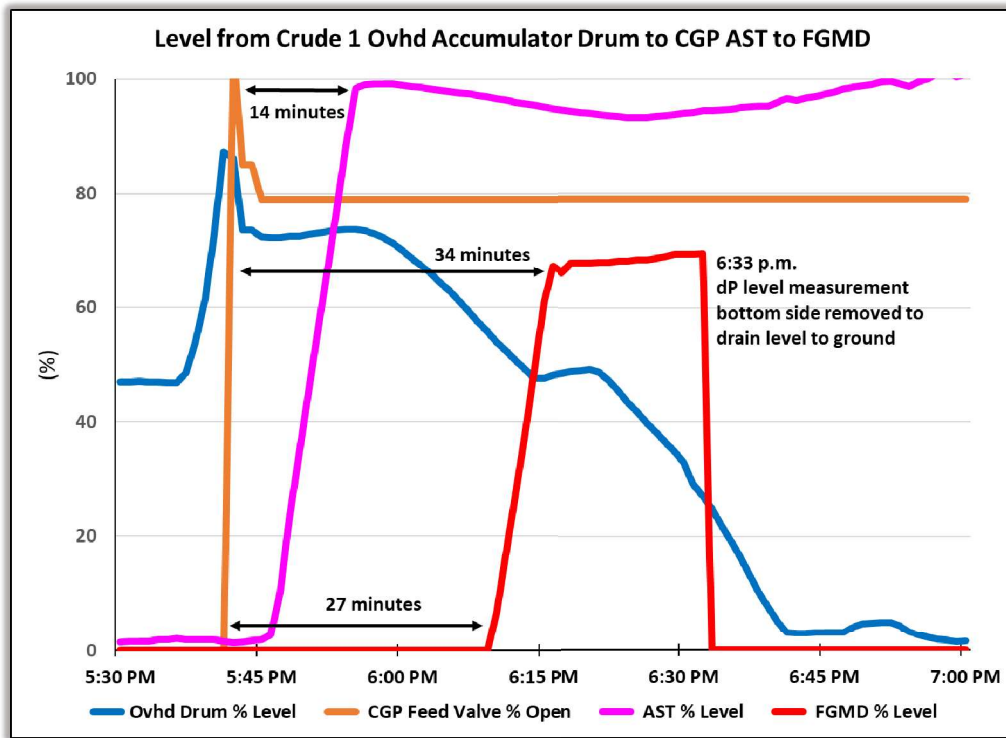
Figure 29 shows the rapid progression of overflow events after the naphtha flow control valve to the Coker Gas Plant was opened by a board operator. In approximately 14 minutes the Coker Gas Plant Absorber Stripper Tower reached 100 percent level and approached overflow through open bypass piping. In approximately seven minutes, naphtha from the overflowing Coker Gas Plant Absorber Stripper Tower filled the six-foot span in the Fuel Gas Mix Drum.

Figure 29. Overflow progression. Decreasing level in the Crude 1 Overhead Accumulator Drum and increasing levels in the Coker Gas Plant Absorber Stripper Tower and Fuel Gas Mix Drum.^a (Credit: CSB)

At this point, the guided wave radar and sight glass indicated the liquid level in the Fuel Gas Mix Drum had reached the top of the measured six-foot level span around 6:15 p.m.^b As the liquid continued to fill the Fuel Gas Mix Drum, these instruments could not provide any indication that the drum was overflowing liquid into the fuel gas piping.

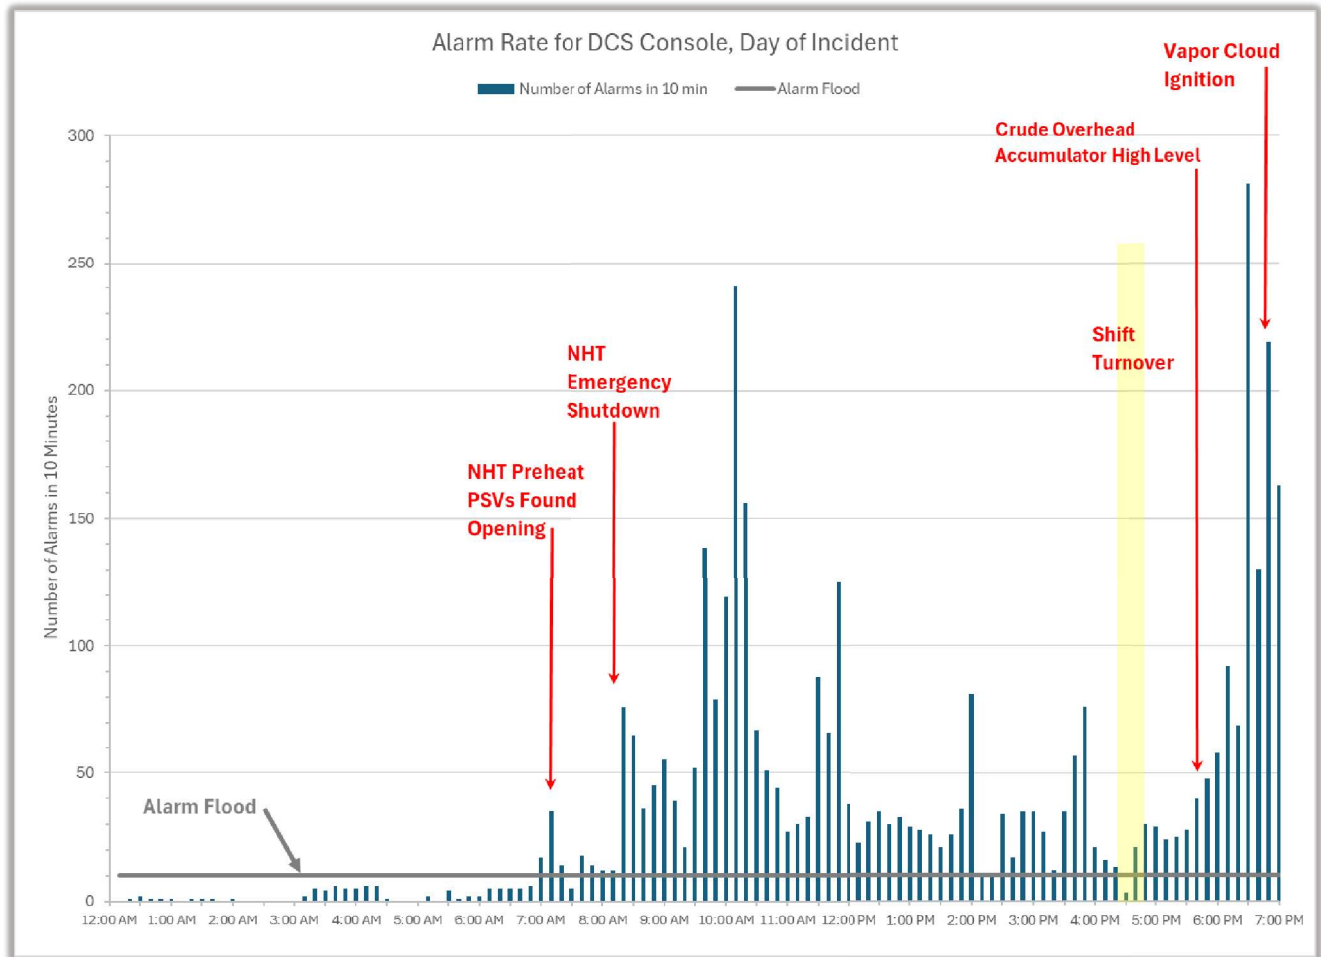
a very large number of alarms, both on day shift and night shift.^{a,b} The alarm rate was at or above 10 alarms in 10 minutes starting at approximately 7:00 a.m., and continuing throughout the day, up to and after the incident at 6:46 p.m., with the exception of two 10-minute periods (although alarms sounded during these two periods as well).^c **Figure 36** shows this alarm rate, in 10-minute blocks throughout the day.

Figure 36: DCS console alarm rate on September 20, 2022, with some process events (in red). The gray line indicates alarm flood rate (10 alarms in 10 minutes). (Credit: CSB)

Figure 36 illustrates the alarm rate that board operators faced throughout the day, with many alarms annunciating at a rapid pace, sometimes for hours together, after the NHT Preheat emergency pressure-relief valve chatter and emergency shutdown that morning and leading up to the incident that evening. Such a situation is virtually impossible to manage for extended periods without missing critical alarms or errors occurring (**Section 4.3.3** below).

The secondary metric for flooding in **Figure 38**, the number of alarms in any 10-minute period, shows the extent of alarm flood the day of the incident. The number of alarms in any 10-minute period was far over the challenging level of performance, or greater than 50 alarms in 10 minutes, for four hours that day between approximately 8:00 a.m. and 7:00 p.m., as shown above in **Figure 36**.

The new policy indicated that “flood events should be analyzed for total percentage of time each month that the alarm system spends in a flood condition.”^a While this is consistent with ISA 18.2, the flood performance metric does not necessarily focus the analysis on plant upsets, which may cause alarm flooding over a period of hours, as occurred the day of the incident (**Figure 36** above).

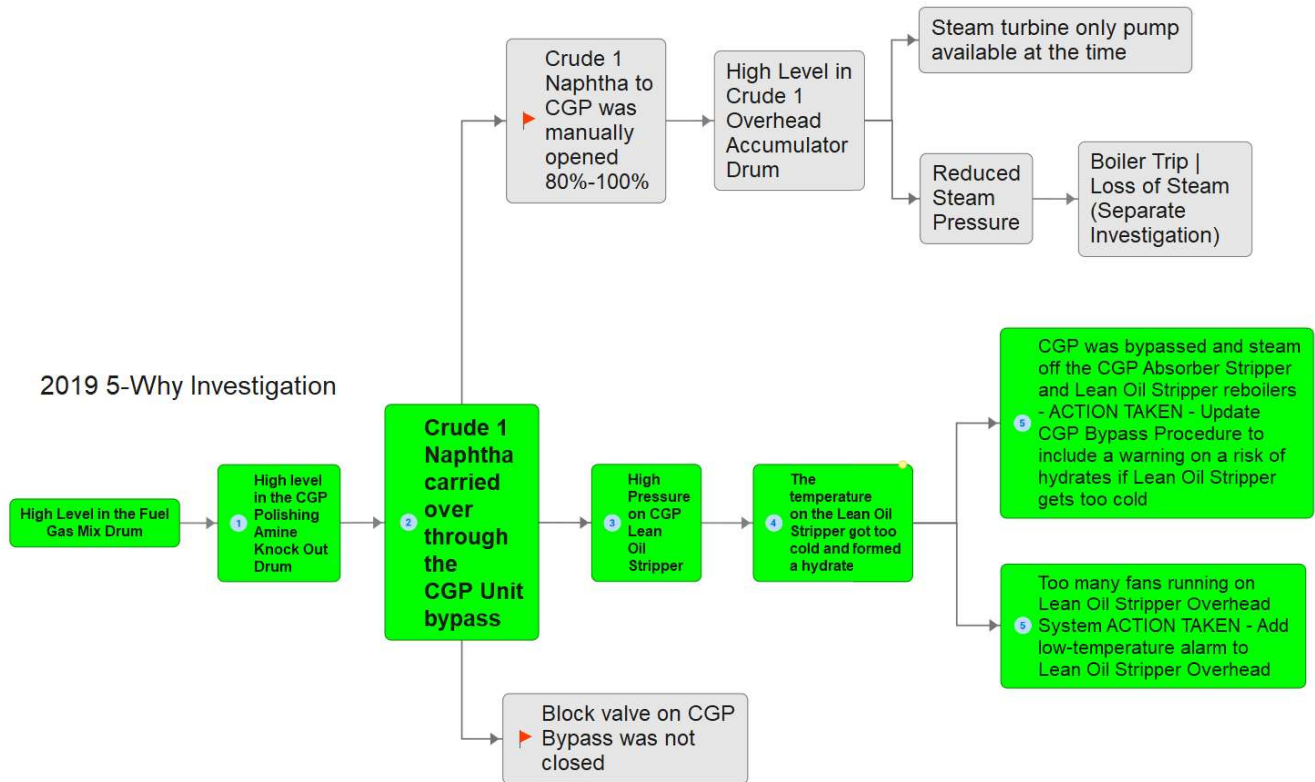
Figure 46 is a graphical representation of the 2019 Five Whys Investigation shown in **Figure 45**. The red flags indicate causes of high level in the Fuel Gas Mix Drum such as high level in Crude 1 Overhead Accumulator Drum and the open Coker Gas Plant bypass that could have prevented the September 20, 2022, incident, but were not addressed with long term actions to prevent future recurrence.

Figure 46. Graphical representation of the Five Whys investigation of high level in the Fuel Gas Mix Drum. (Credit: CSB)
